INTEROFFICE CORRESPONDENCE

DATE: August 5, 1991

SUBJECT: OPERATIONS AND SURVEILLANCE REPORT CONCERNING THE SOUTH INTERCEPTOR
DITCH -- DSM-016-91

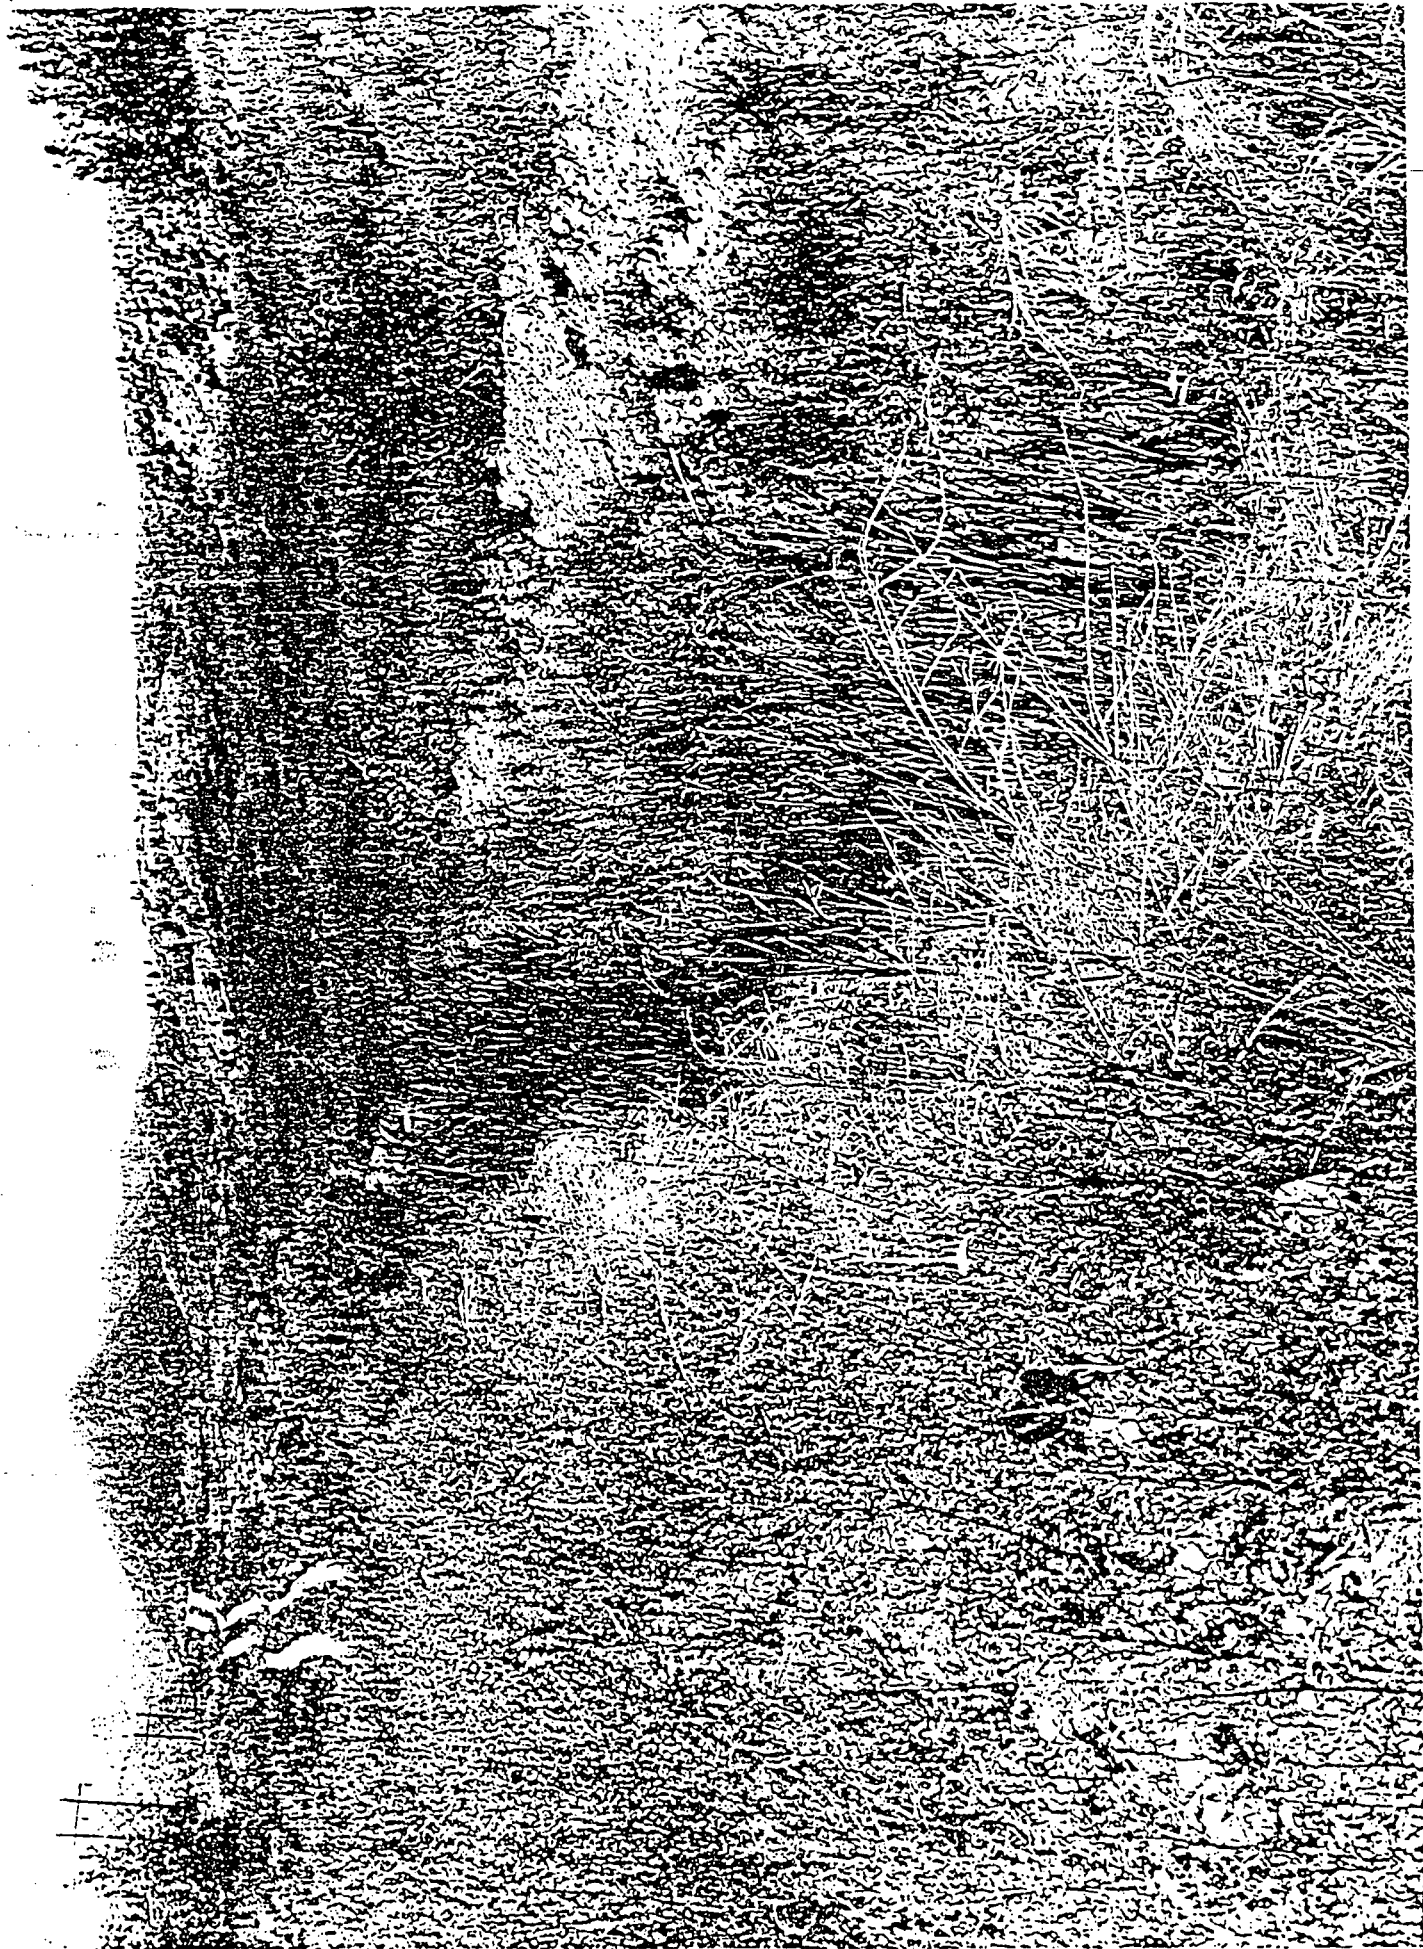
2. South Interceptor Ditch, West segment, West Aspect, Near old landfill area; Hole metal refuse and vegetative growth.

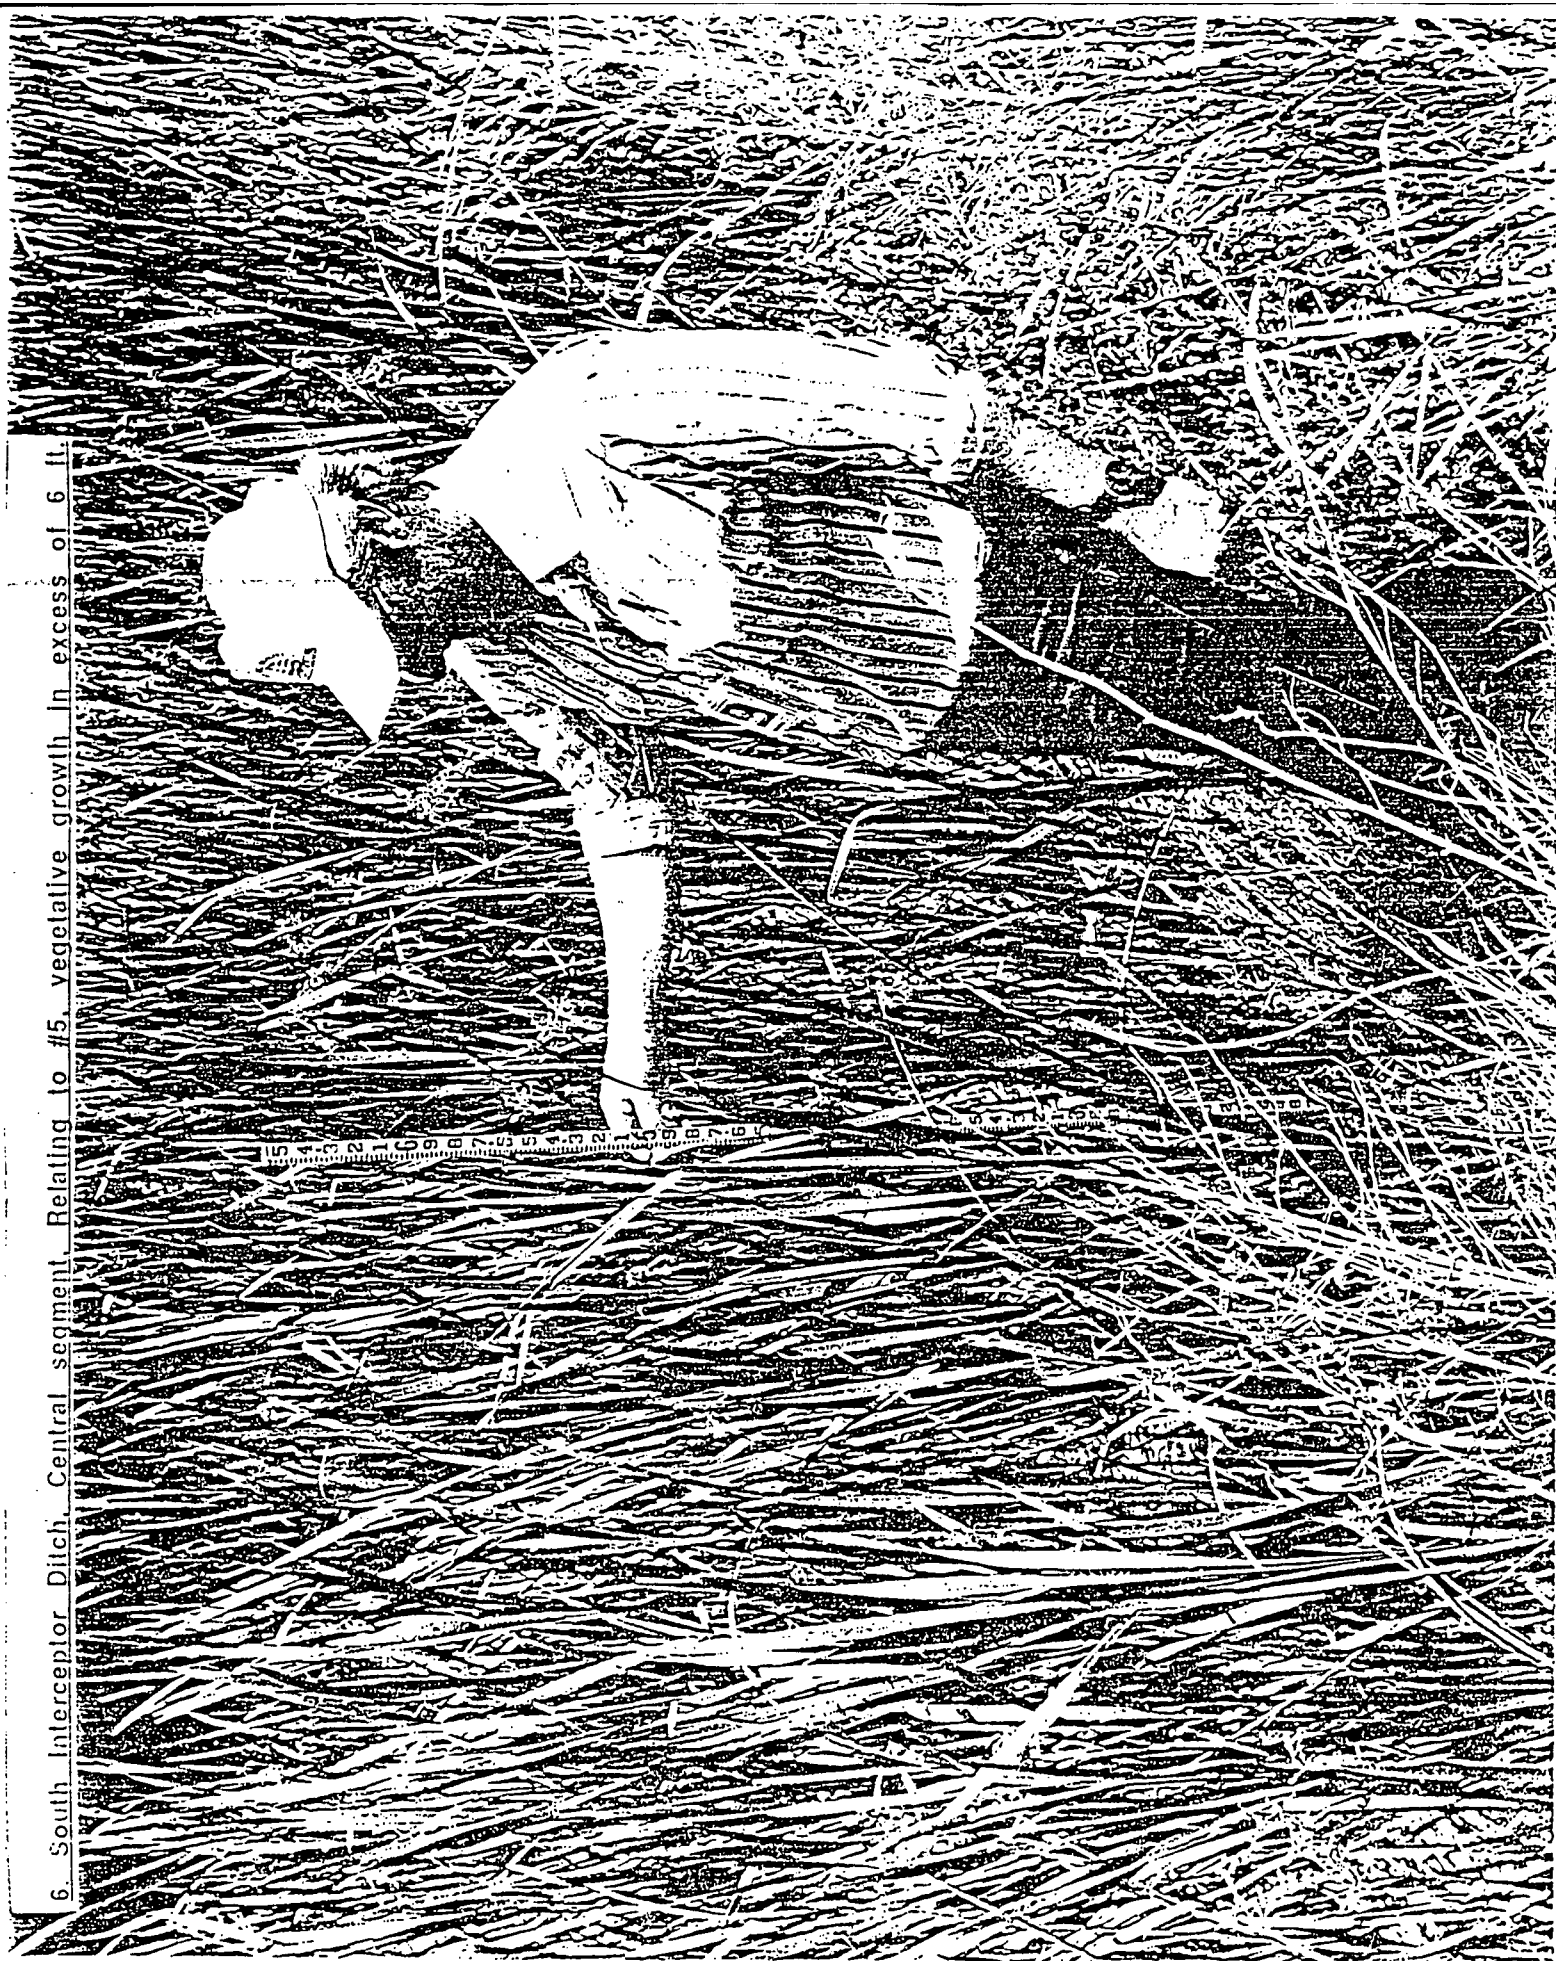
6. South Interceptor Ditch. Central segment. Relating to #5. vegetative growth in excess of 6 ft.

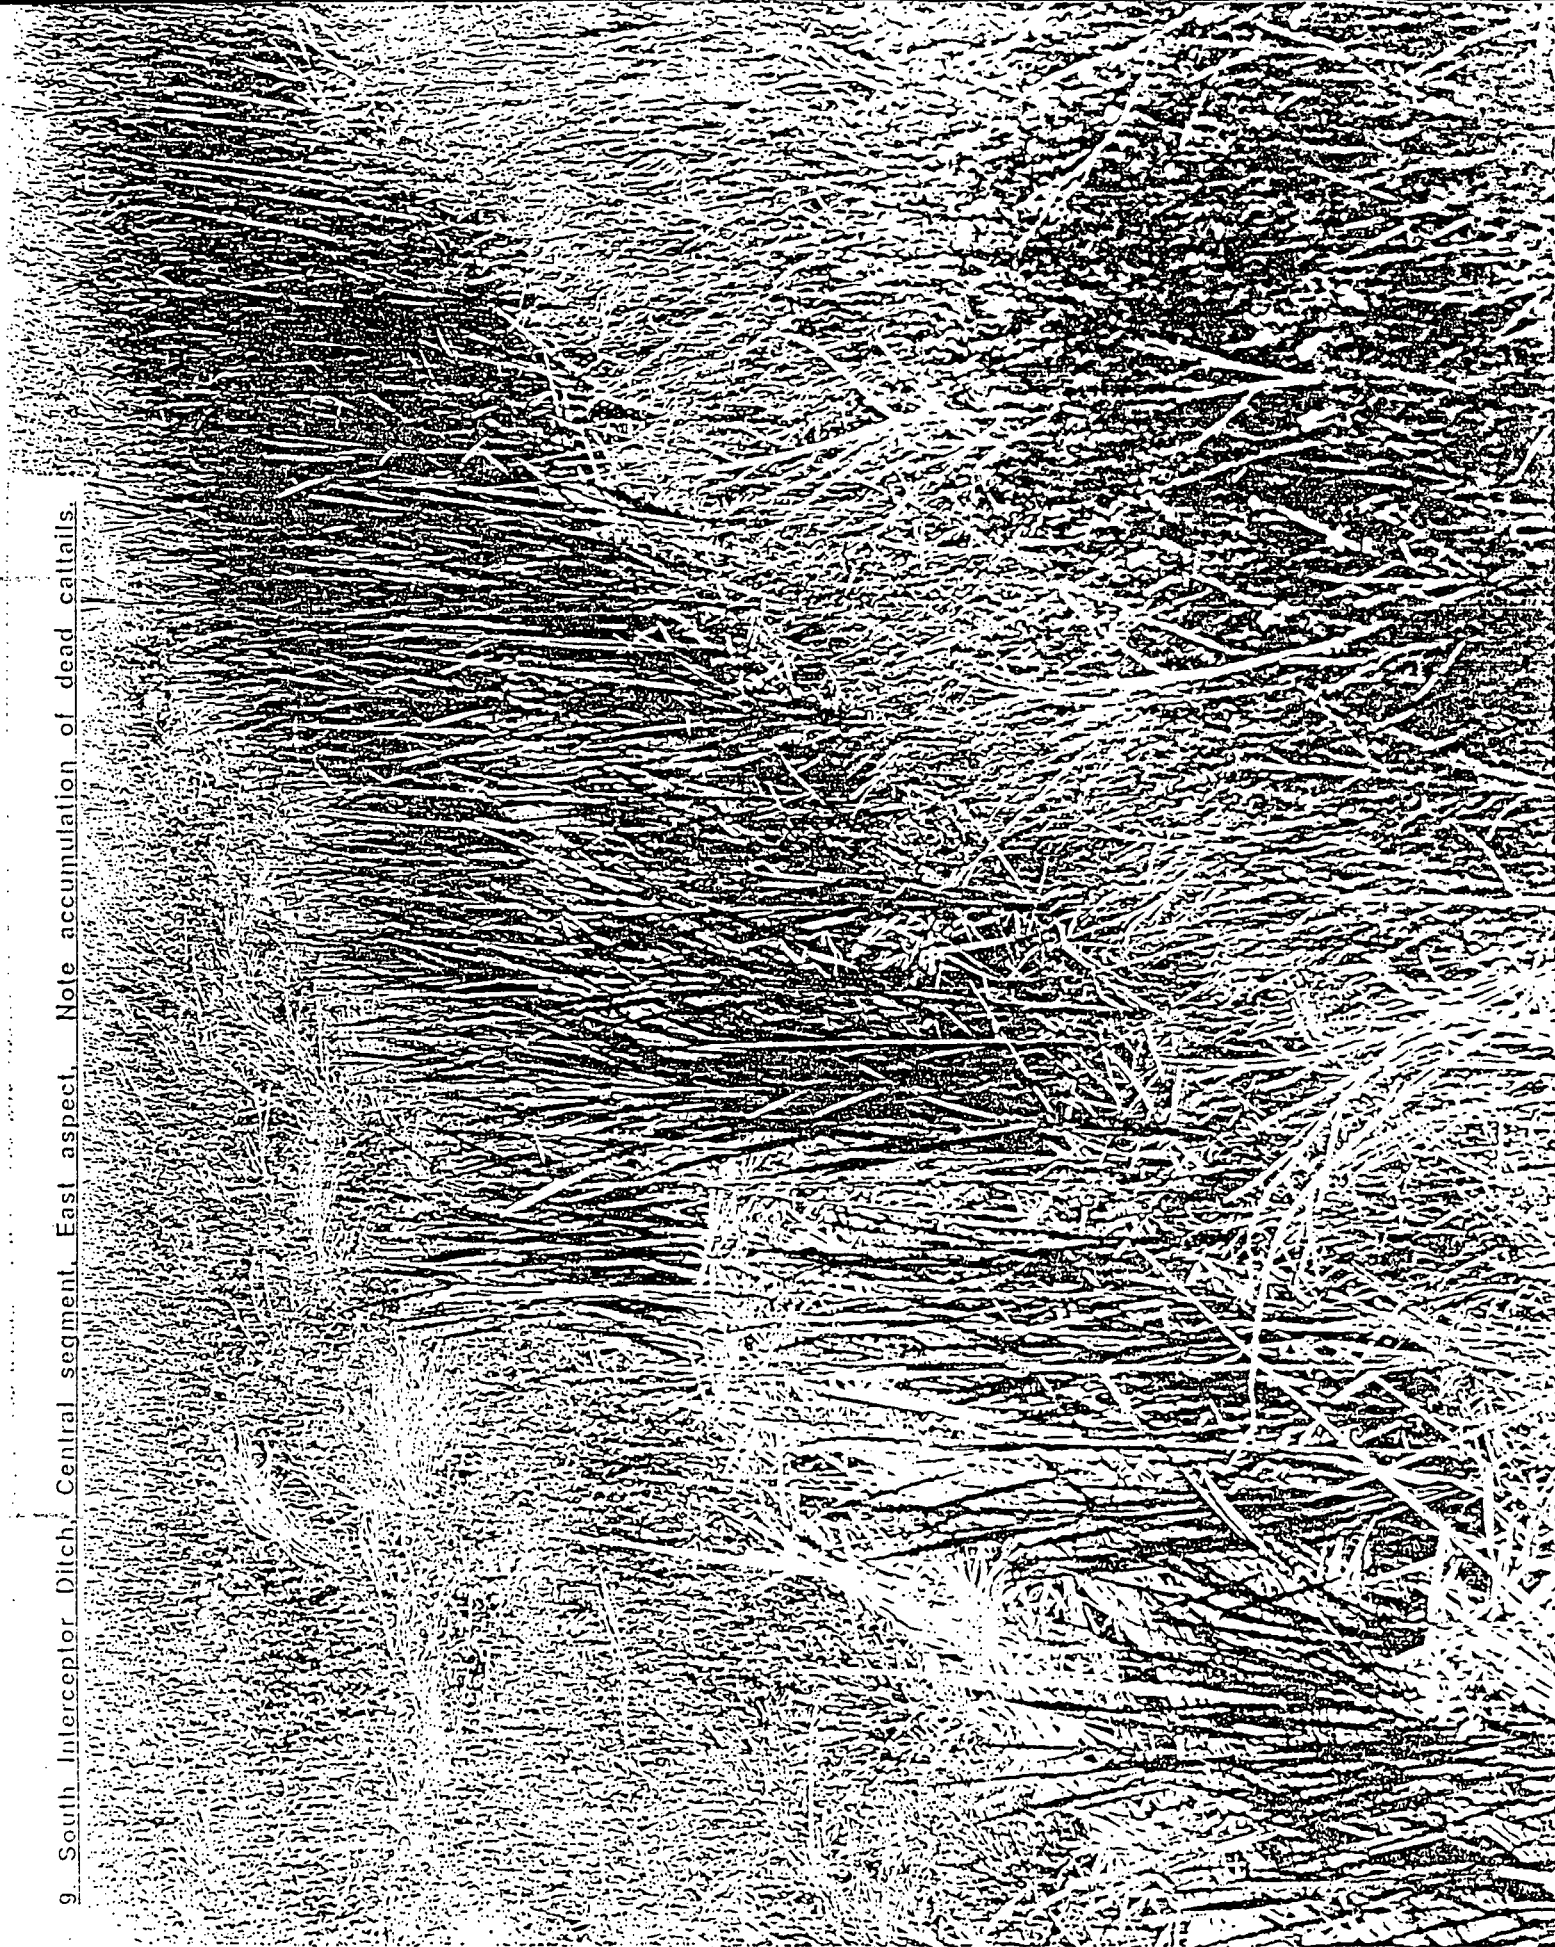
9. South Interceptor Ditch, Central segment, East aspect. Note accumulation of dead cattails.

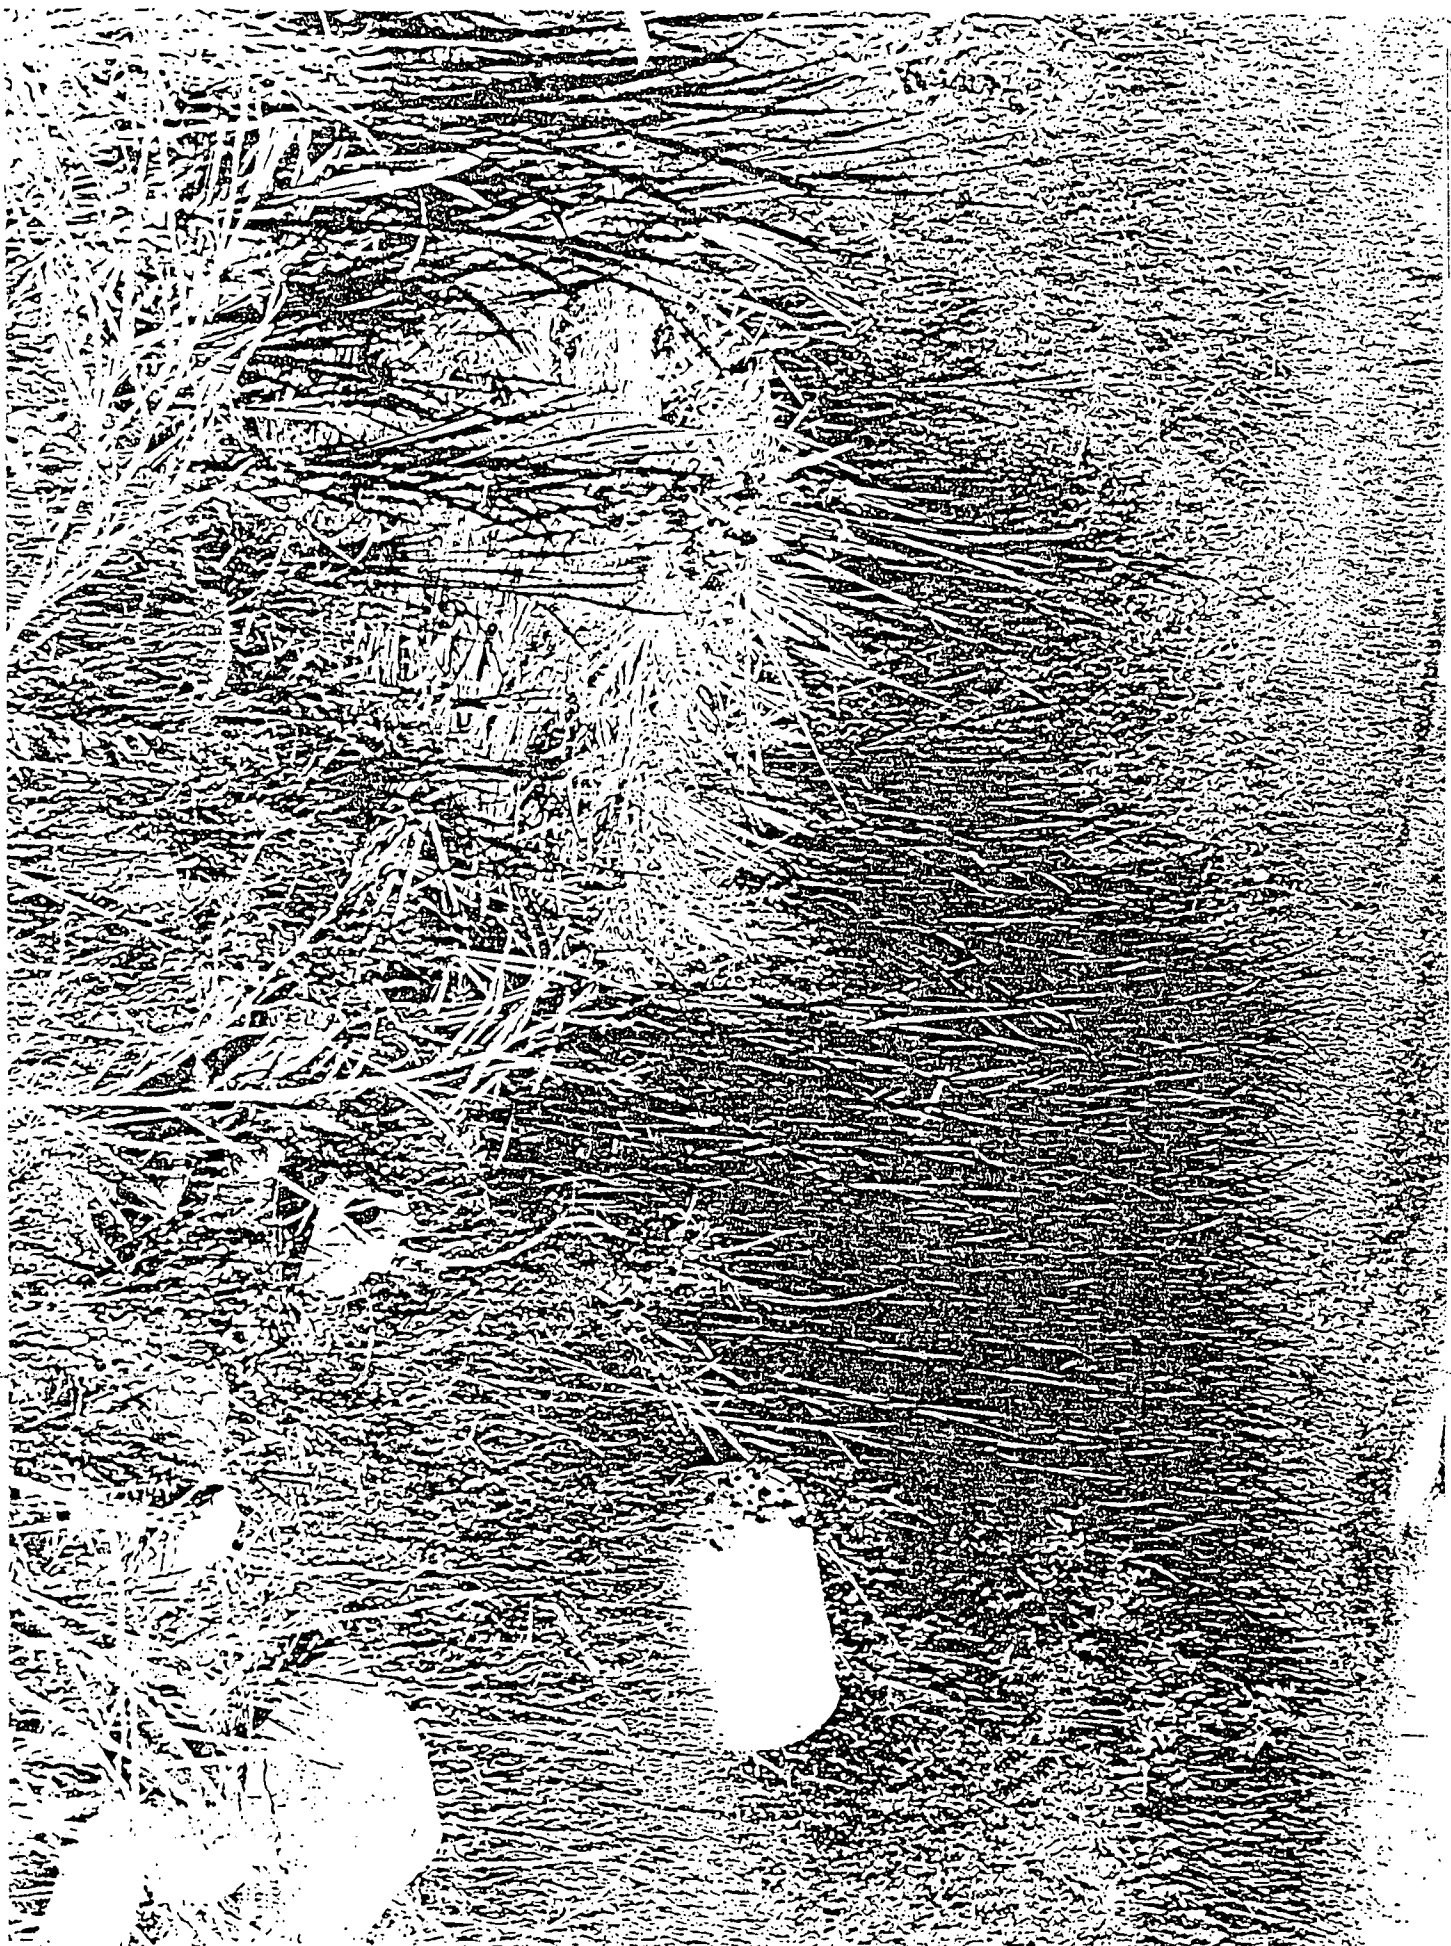
10. South Interceptor Ditch, Central segment, East aspect. Note accumulation of dead cattails and 55 gallon drum.

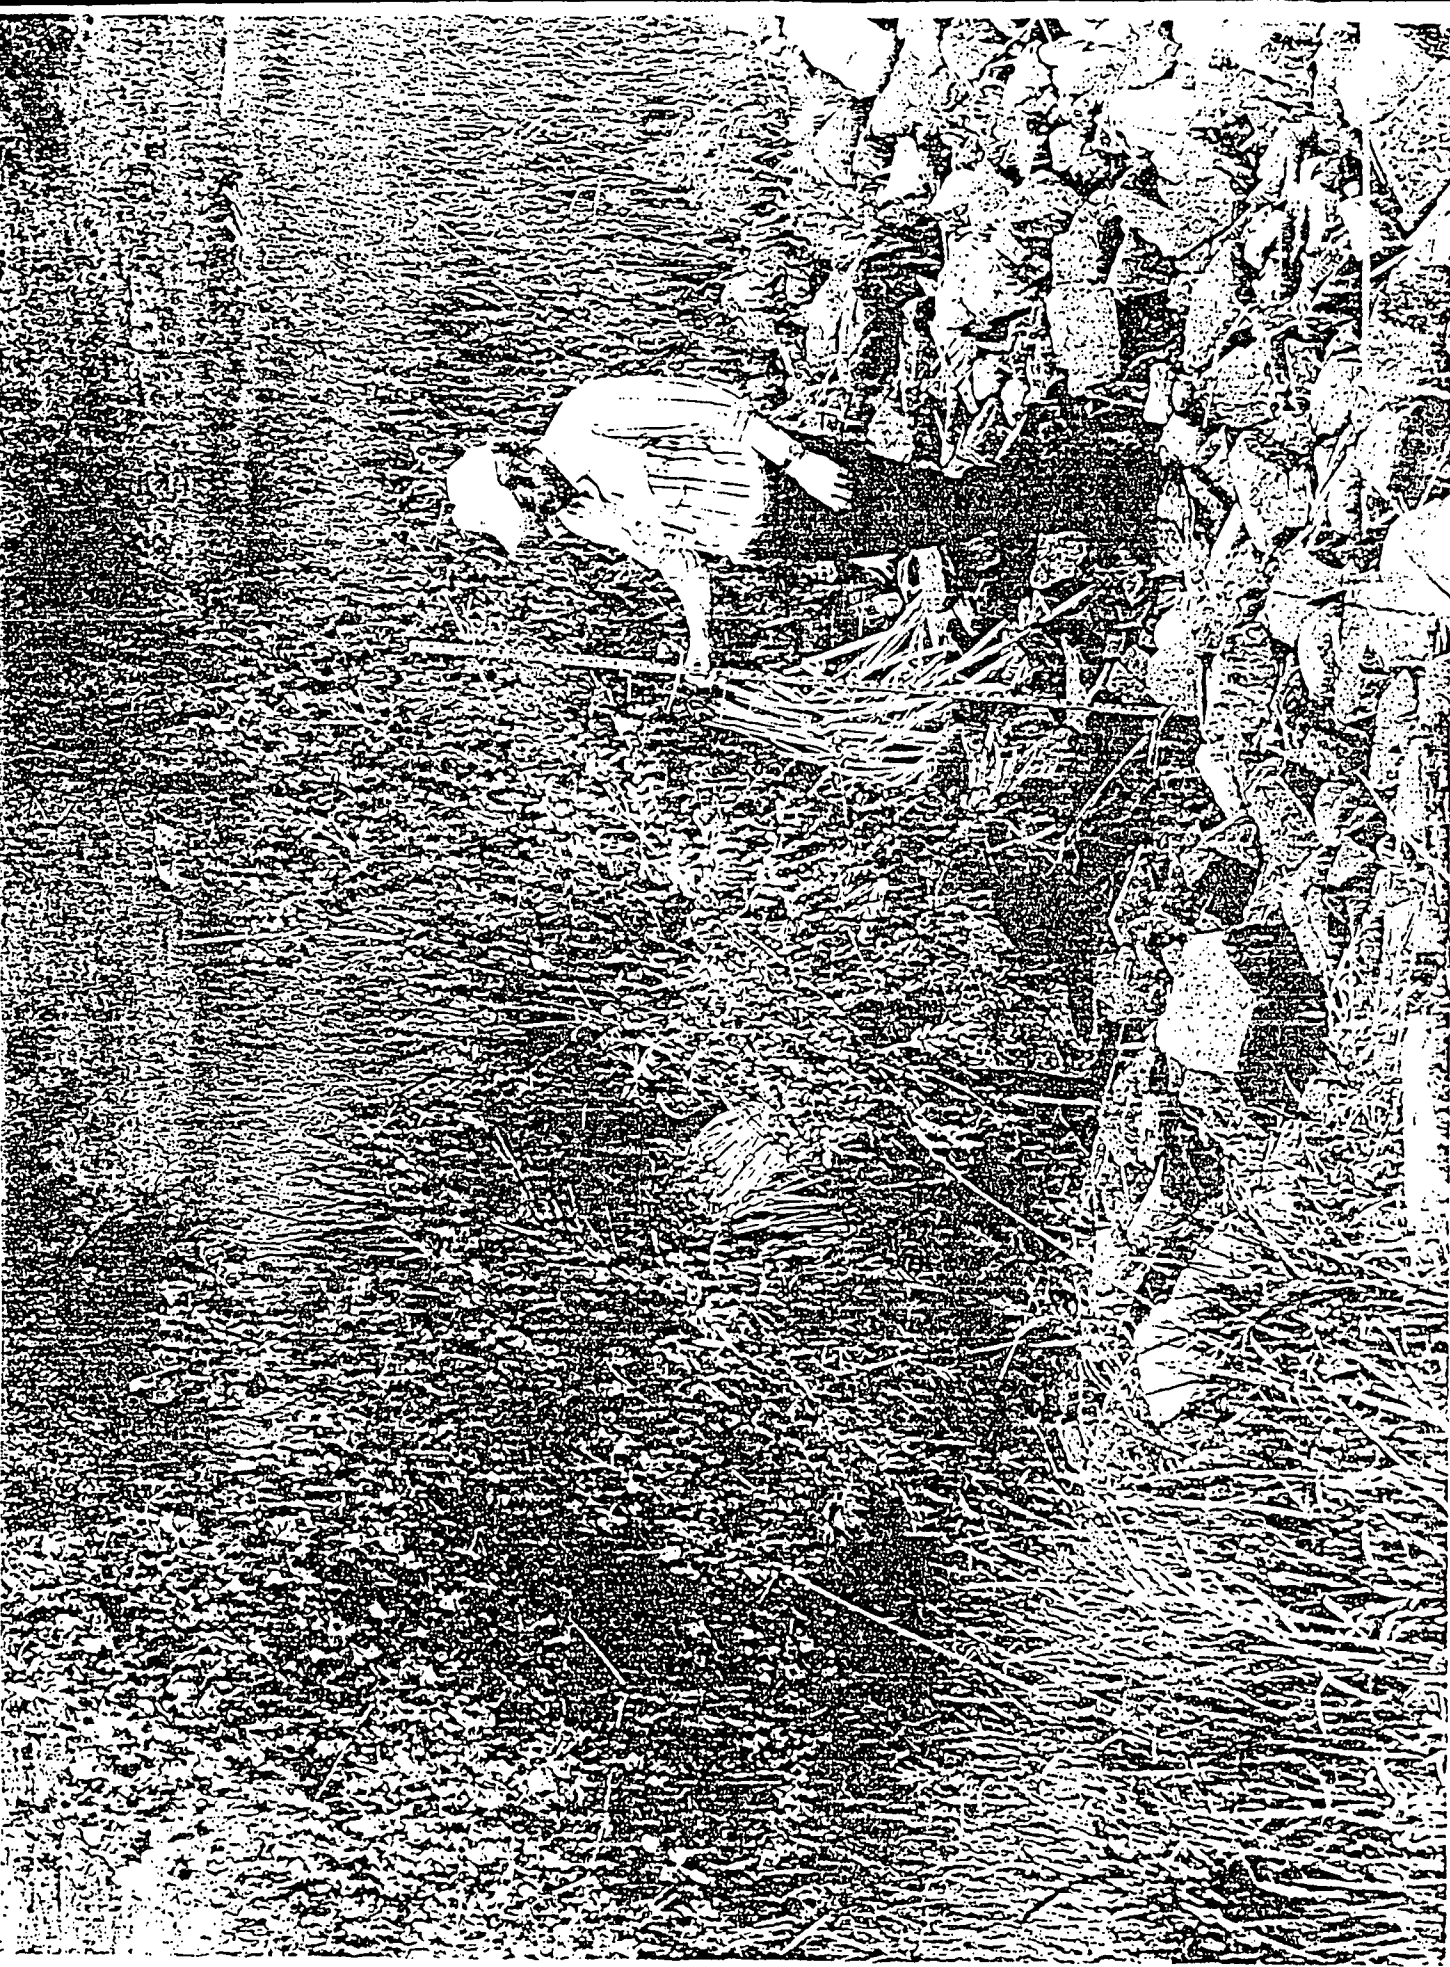
11. South Interceptor Ditch, Central segment. Note trees in upstream portion of energy dispersion area. Note condition of rip-rap.

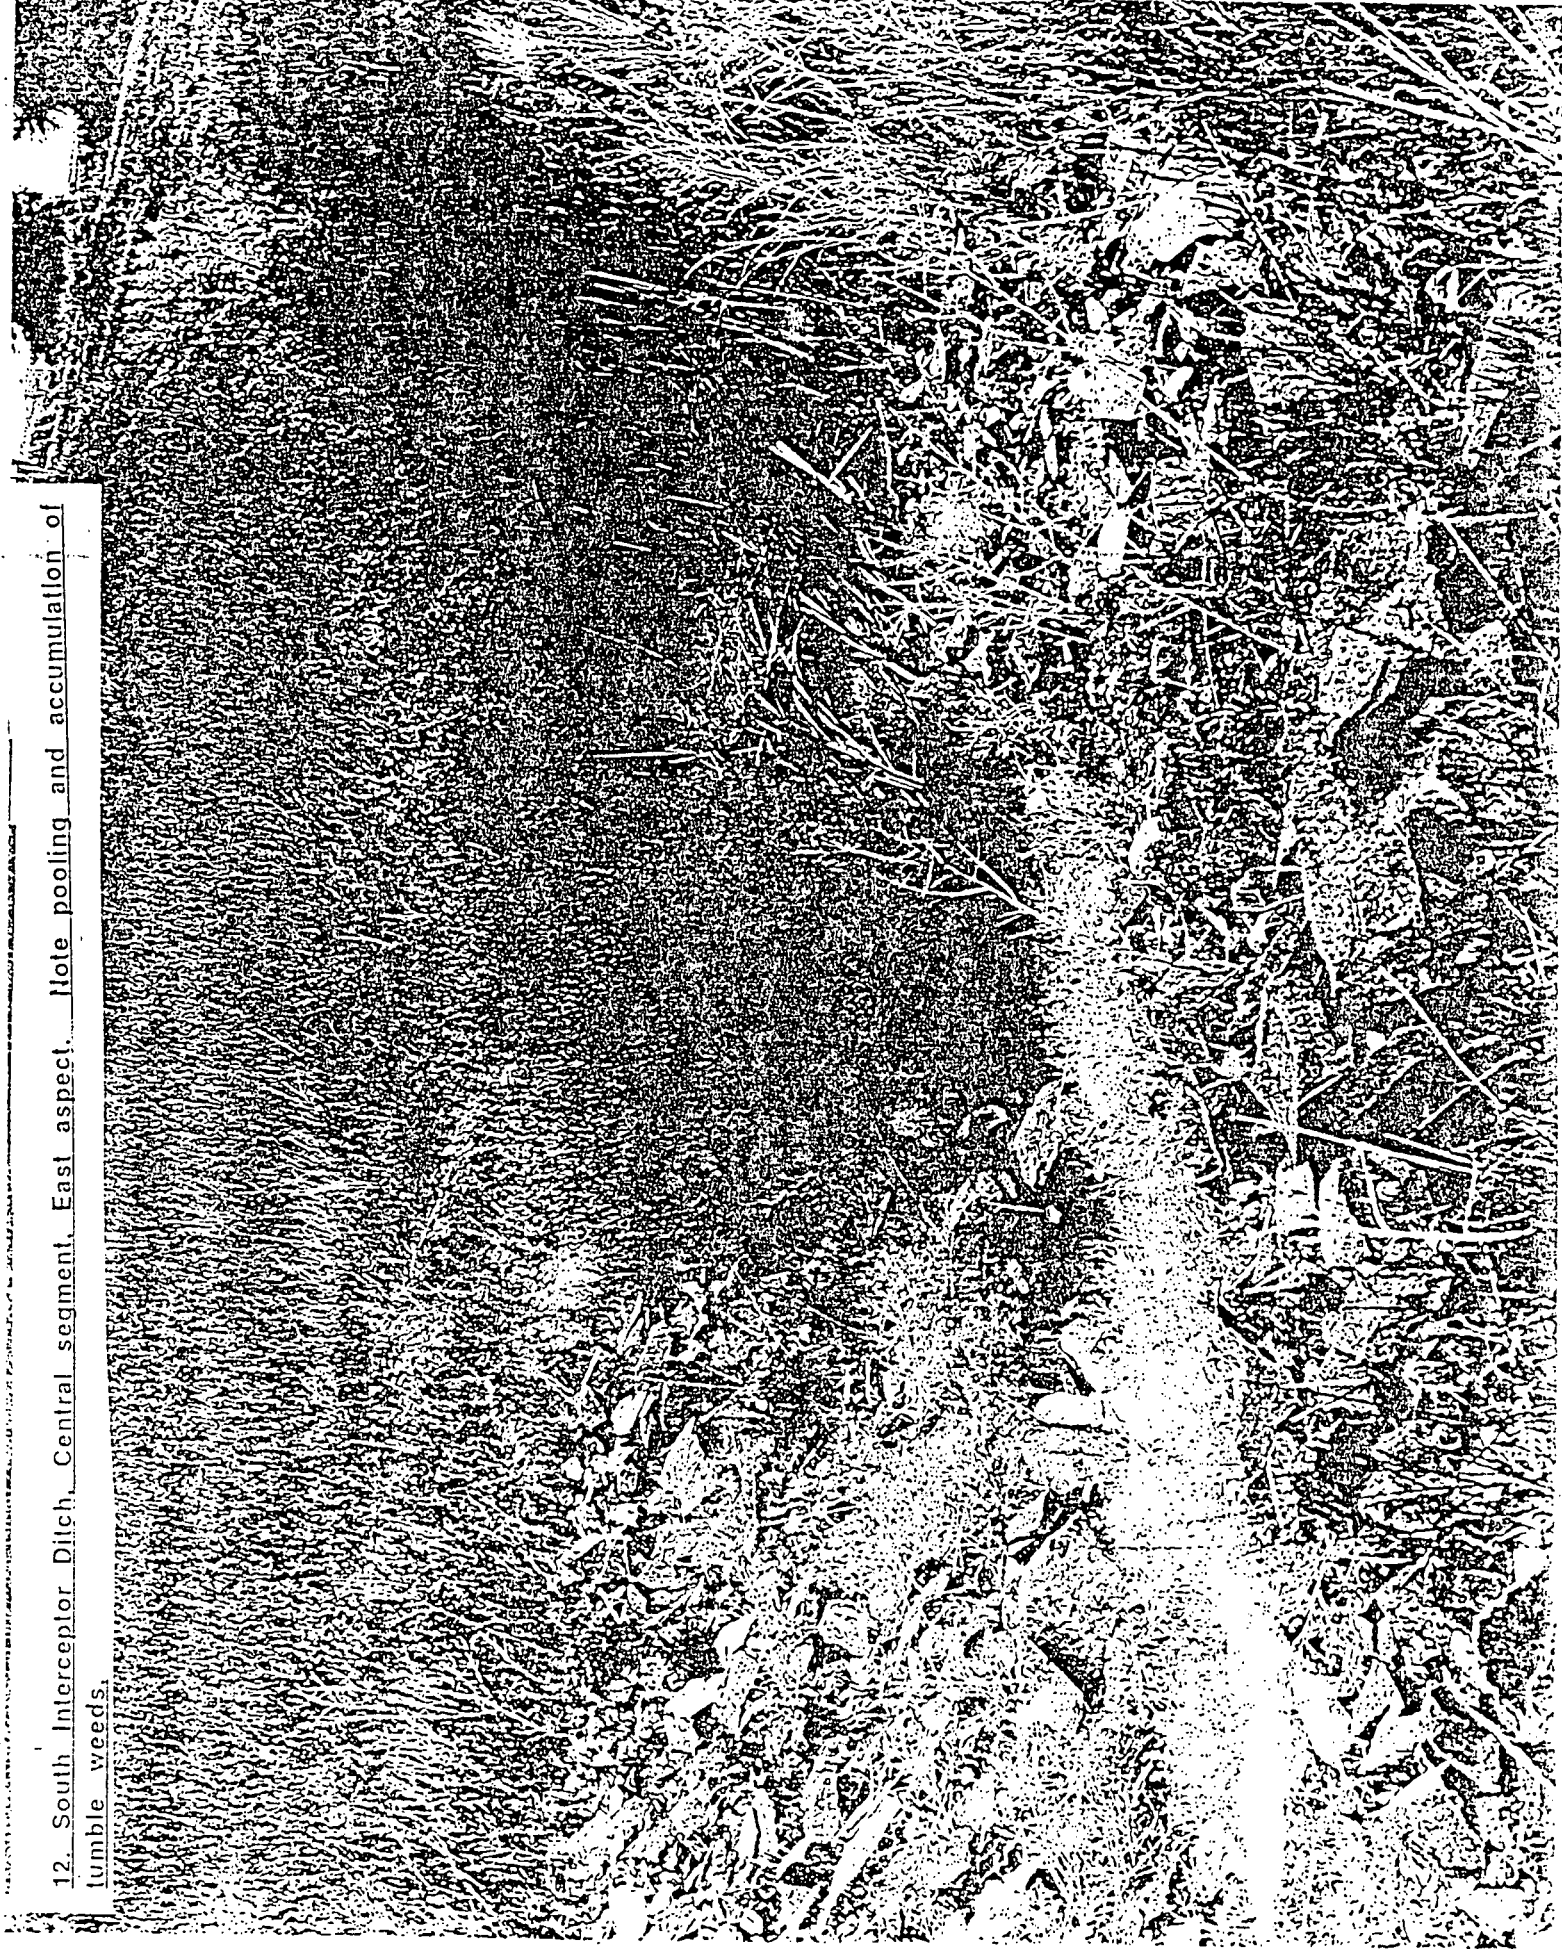
12. South Interceptor Ditch, Central segment, East aspect. Note pooling and accumulation of tumble weeds.

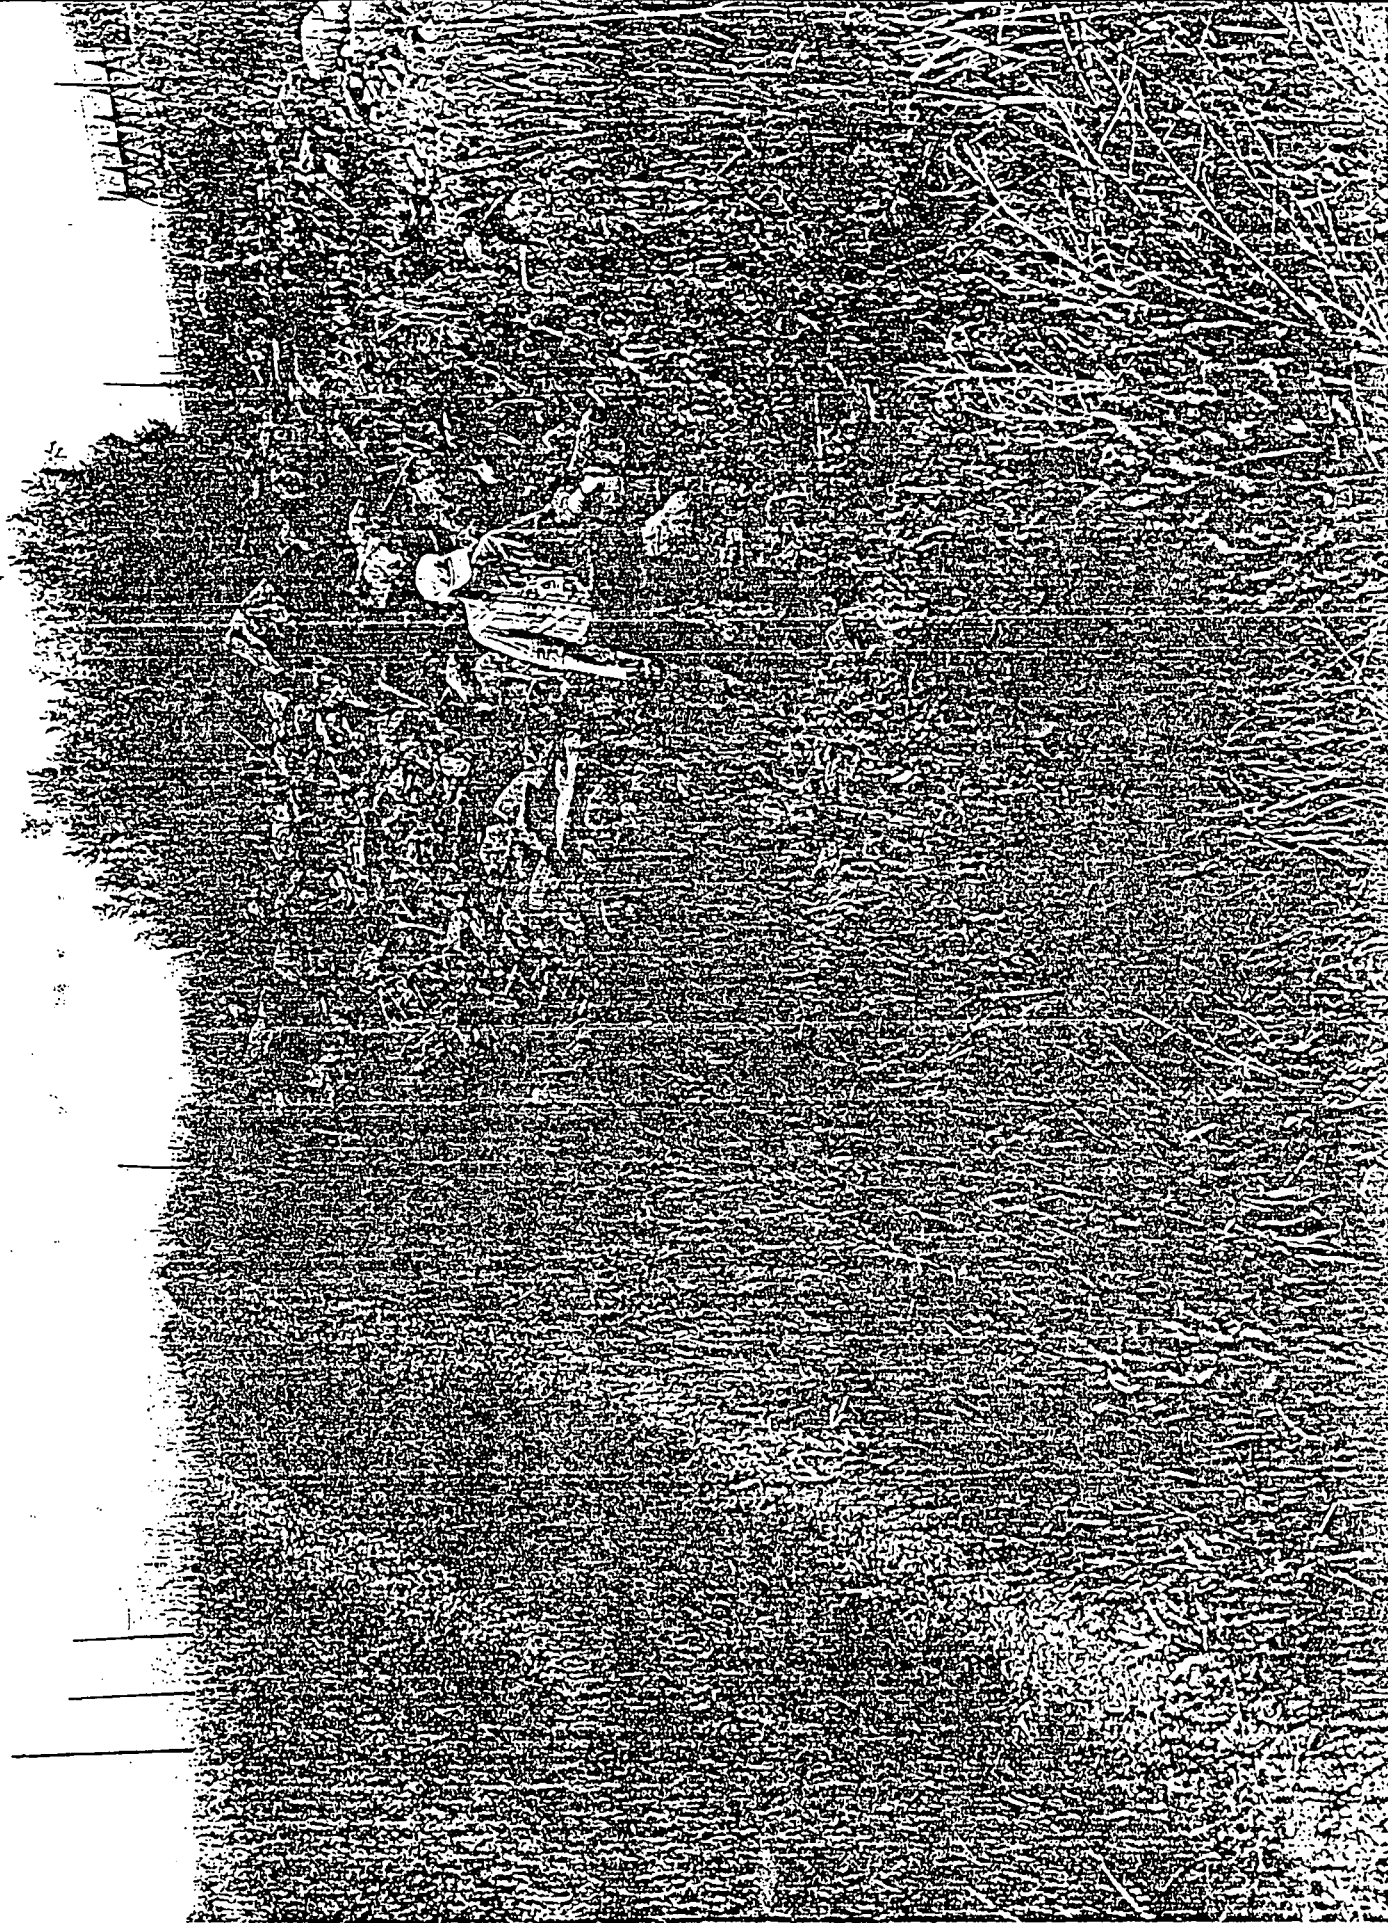
13. South Interceptor Ditch, Central segment, West aspect. Note condition of rip-rap in background. Note height of bottom of ditch to crest of dike. Approximately 2 ft. to overlapping of dike occurs.
